Renovation of Royal Theatre Carré,  
Amsterdam

### Description of the project:

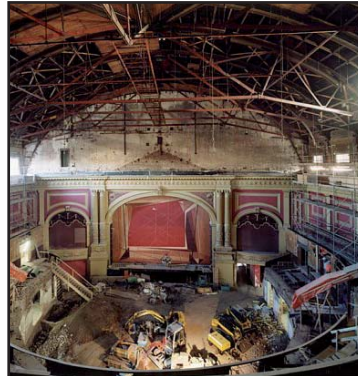
Auditorium during renovation, photo Frank Greiner
